Manhole Inspection Summary

Manhole # S31GG_039MH

Insp Date: **1/19/07 11:31 AM**

Location Address: **1207 JOHN ST**

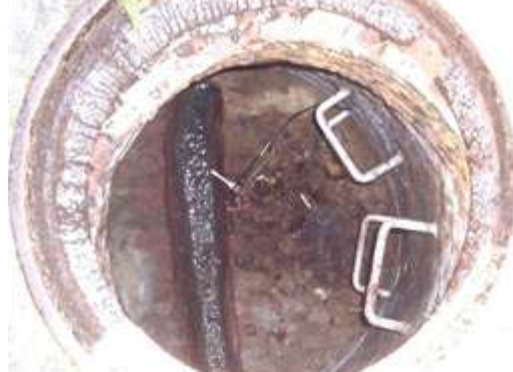
Top View

Bench debris.

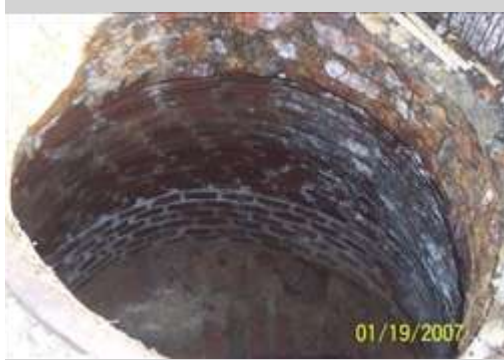
Defect

Frame offset. Adjustment deterioration and infiltration. Corbel and Barrel infiltration - other side.

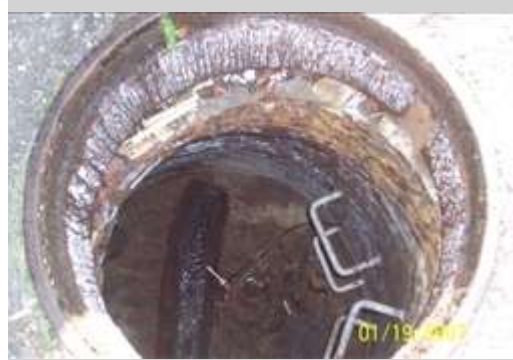
Defect

Frame offset. Adjustment deterioration and infiltration.

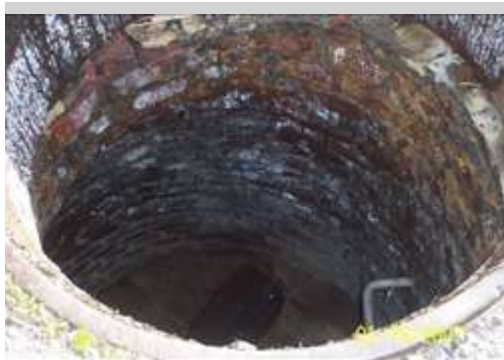
Defect

Frame offset. Adjustment deterioration and infiltration. Corbel and Barrel infiltration.

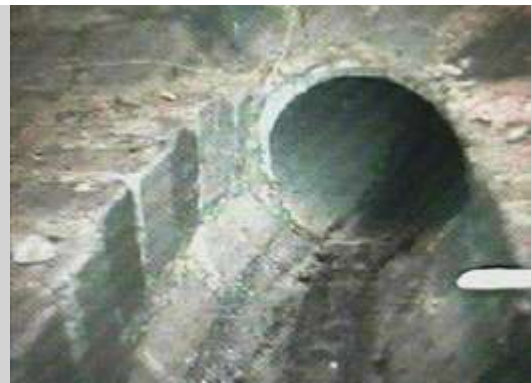
Pipe Out @ 12 O'Clock

Infiltration: **Evidence** Pipe Seal Cond: **Unknown**

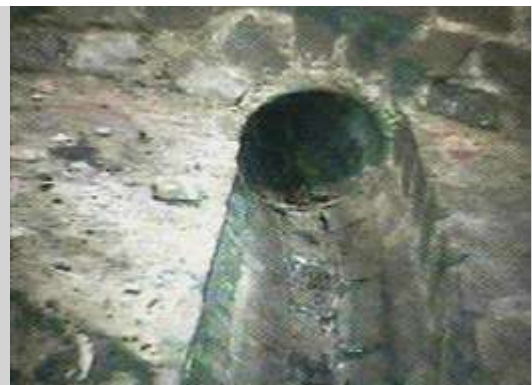
Pipe In @ 6 O'Clock

Infiltration: **Evidence** Pipe Seal Cond: **Unknown**
